# FACILITY COMPLIANCE AUDIT REPORT

## Division of Waste Management Solid Waste Section

Date of Audit: 9/19/12

Active C&D over Closed MSW Land Fill – Johns River Facility  
2500 Marsh Trail Rd.  
Morganton, NC 28680

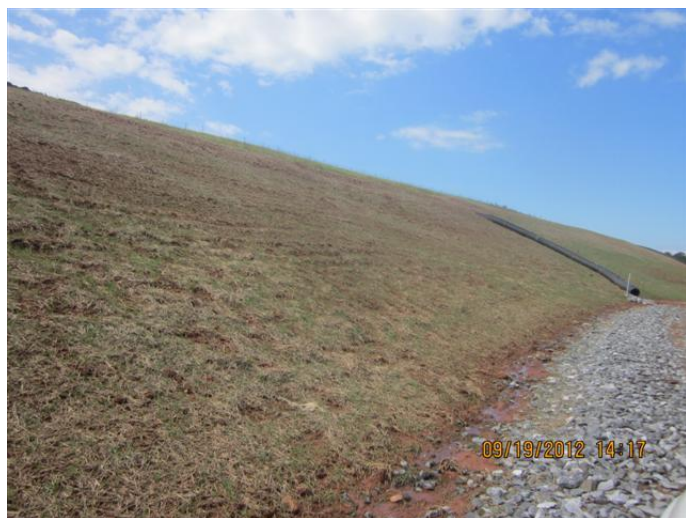
1. Looking N down the recently reworked and reseeded east side of the closed MSW landfill. (Photo taken on 9/19/12)

effects of settlement, subsidence, erosion, or other events, and preventing run-on and run-off from eroding or otherwise damaging the cap system.” (Photos #1 through #3)

1. **CORRECTIVE ACTIONS IN PROGRESS: 15A NCAC 13B .0542(f)(2)** for the failure to maintain a vegetative ground cover or other stabilizing material on the northern and western slopes of the C&D landfill which have not received wastes within the past three months, nor has final termination of disposal operations occurred in this area. Burke County has re-shaped the slopes of the C&D and the MSW landfills where needed; installed berms and surface water collection piping where needed and Burke County has begun hydro-seeding the slopes of the landfills. (Photos #1 through #3 and #6 )

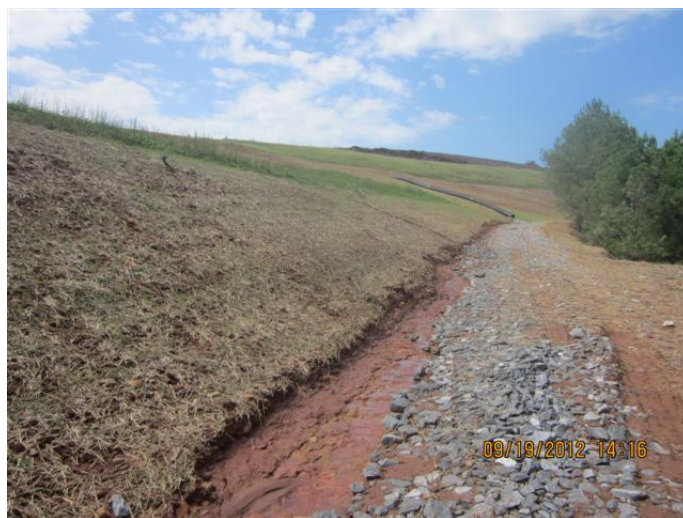
1. Hours of operation: M-F: 7AM – 4PM Sat: 7AM – 1PM
2. No areas of exposed C&D waste were observed. (This has been a problem in the past.)
3. All access roads are well maintained and passable. (Photos #2).
4. The facility's wood waste grinder is down for repairs.

2. Looking north at recently reworked and reseeded section of the eastern slopes of the closed MSW landfill. (Photo taken 9/19/12)

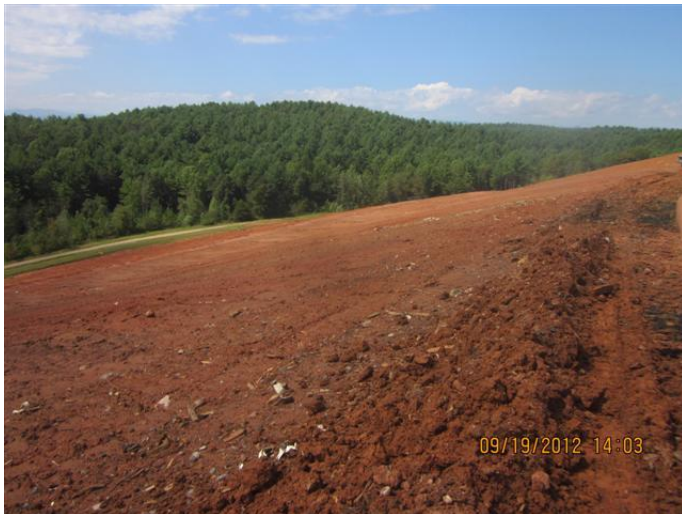
3. Looking north along the recently reworked western slopes of the C&D landfill. Photo taken 9/19/12

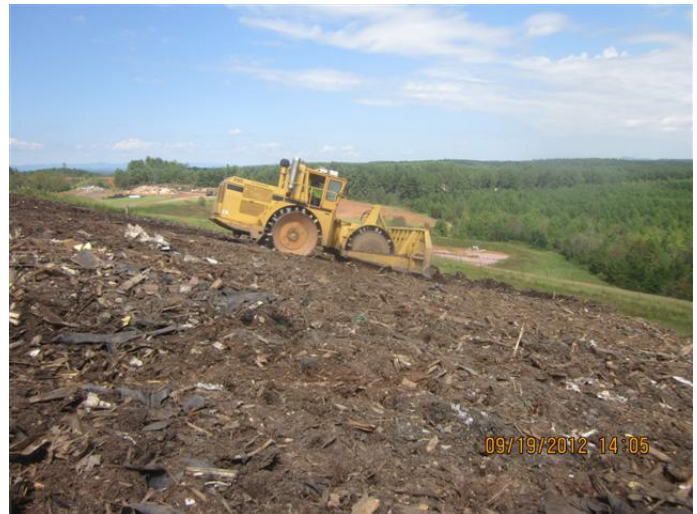
4. Compactor working the SE quadrant of the working face. Photo taken 9/19/12

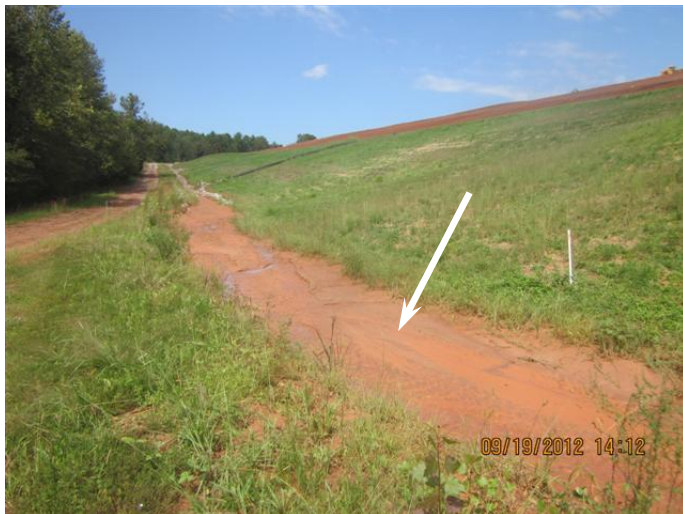
5. Looking N down the perimeter stormwater ditch on the west side of the landfill that is filled with silt. Access road is to the left. Photo taken on 9/18/12

14. Due to heavy rains over the past two days (approximately 3.5-inches), the perimeter stormwater ditches have accumulated a great deal of remove silt. This silt will need to be removed. (Photo #5)
15. In accordance with 15A NCAC 13B .0542(f)(2), please ensure that areas of the C&D landfill which will not have additional wastes placed on them for three months or more, but where final termination of disposal operations has not occurred, must be covered and stabilized with vegetative ground cover or other stabilizing material.”

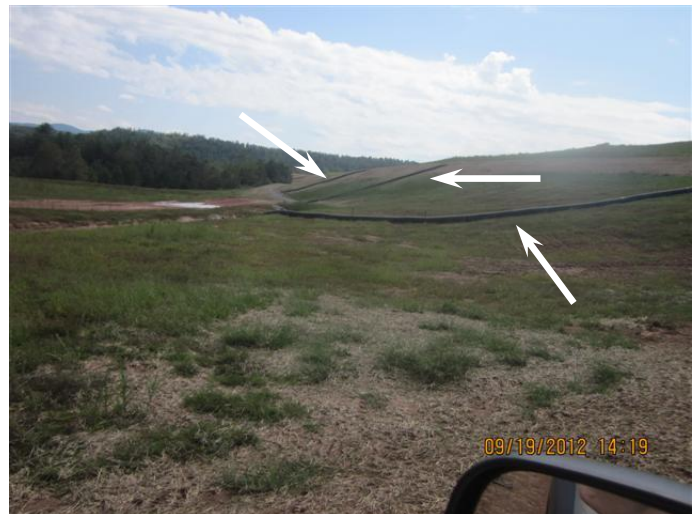
6. Looking S down the east side of the landfill. Note the three newly installed surface water collection and diversion pipes. (Photo taken on 9/18/12)
